DEPARTMENT OF TRANSPORTATION

Contract #: 04-0120F4Cty: SF/ALA Rte: 80 PM: 13.2/13.9File #: 69.28**WELDING INSPECTION REPORT****Resident Engineer:**Pursell, Gary**Address:** 333 Burma Road**City:** Oakland, CA 94607**Report No:** WIR-015611**Date Inspected:** 14-Jul-2010**Project Name:** SAS Superstructure**OSM Arrival Time:** 700**Prime Contractor:** American Bridge/Fluor Enterprises, a JV**OSM Departure Time:** 1900**Contractor:** Zhenhua Port Machinery Company, Ltd (ZPMC), Changxing Island **Location:** Shanghai, China

OBG SEGMENT 9BE-9CE

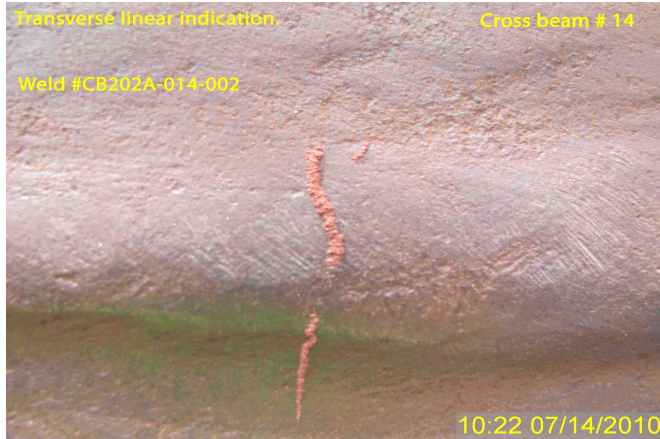
During the magnetic particle inspection on the repair areas of weld CB202A-014-002 ABF QA Inspector found a transverse linear indication. Y location of indication measured approximately 4660mm. The length of indication was measured approximately 25mm. see attached photo.
